# Check Out

Property inspected by Kelvin Bateson-Keys

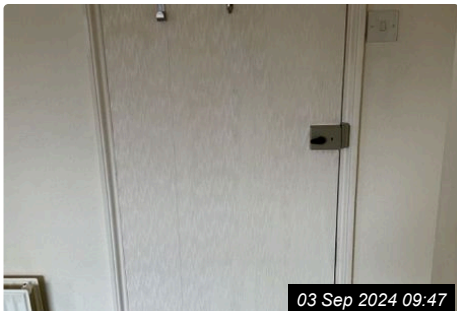
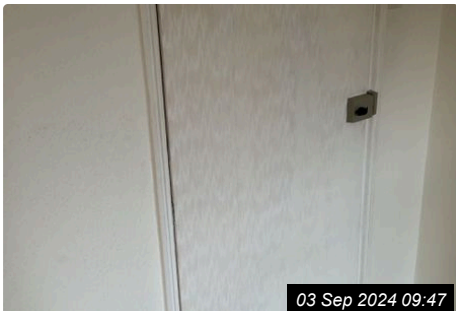
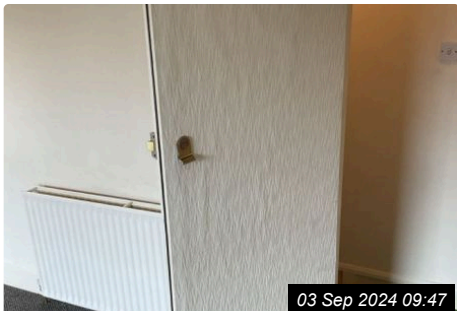
| Ref | Name | Description | Condition | Additional Comments |
|---|---|---|---|---|
| 6.2 | Door | Wooden Painted White<br>Coat Hook<br>Handle<br>Yale Lock | Both sides have been wallpapered | |

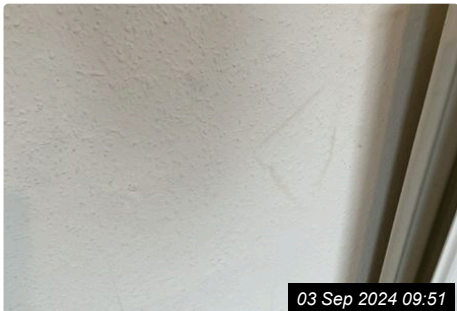
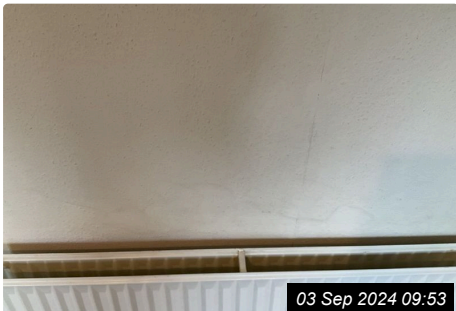
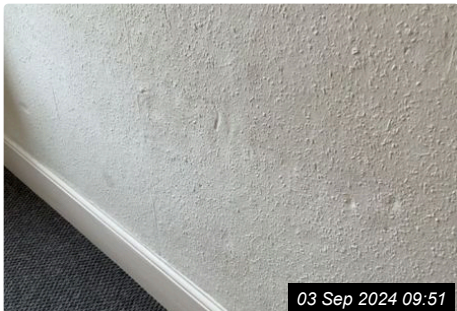
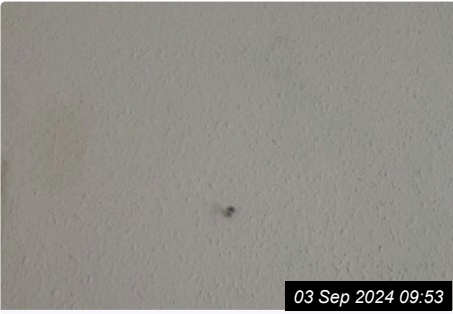
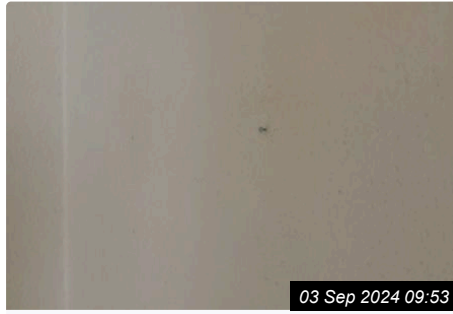
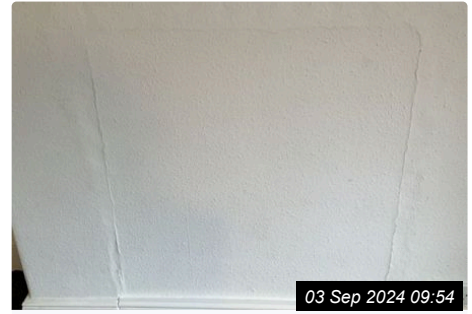
| 6.3 | Walls | Painted paper | <p>Marks left and above the radiator</p> <p>Marked/shading on end wall by kitchen</p> <p>Nail left of flat door</p> <p>Screw left flat door</p> <p>Cracking around fireplace boarding</p> | |

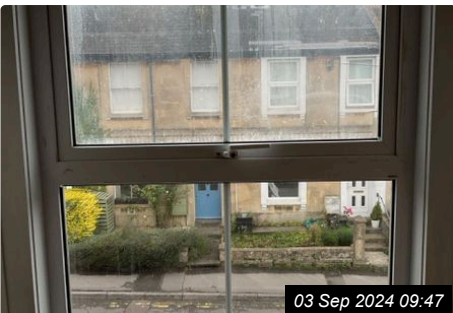
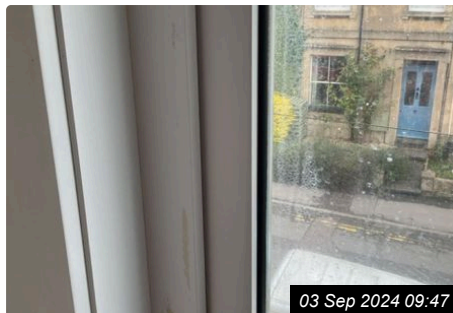
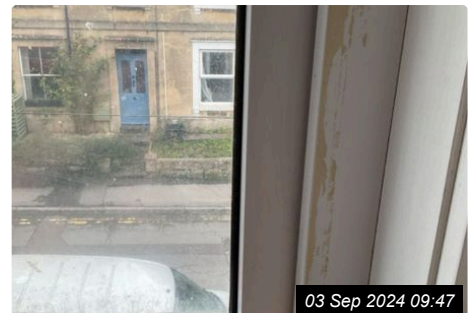
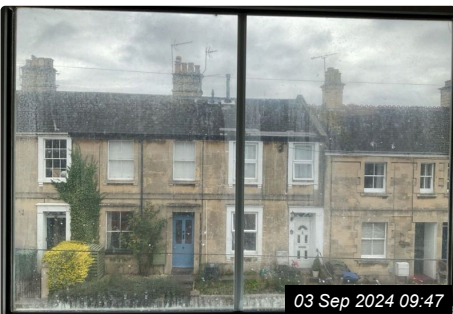
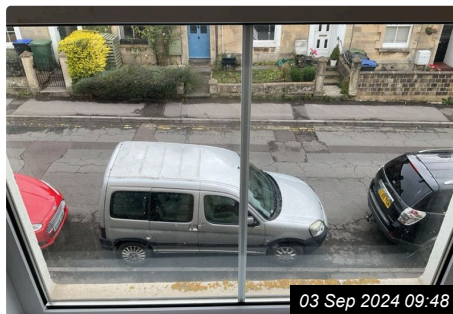
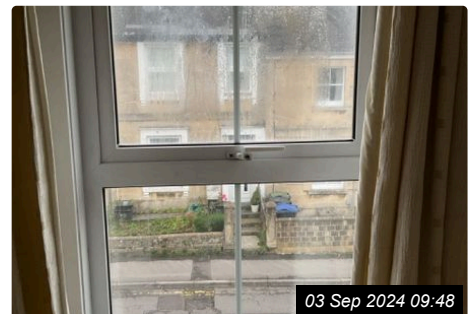
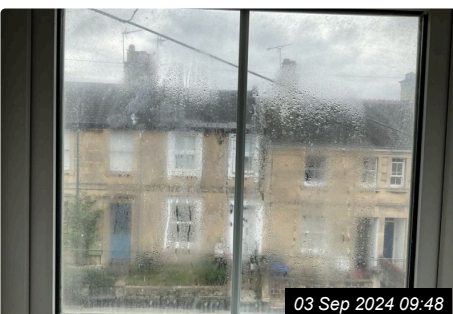
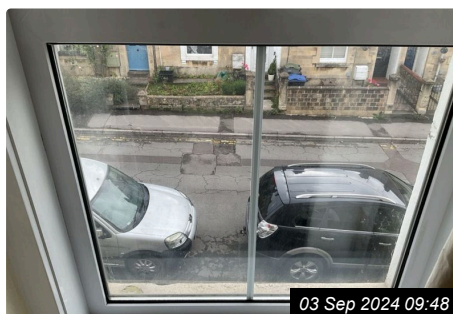
6.4

Brown marks on left hand frames  
Appears right hand pane blown  
Dirty both sides

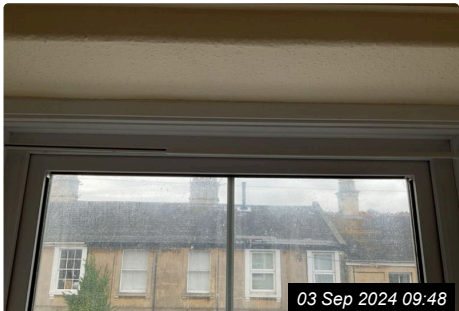
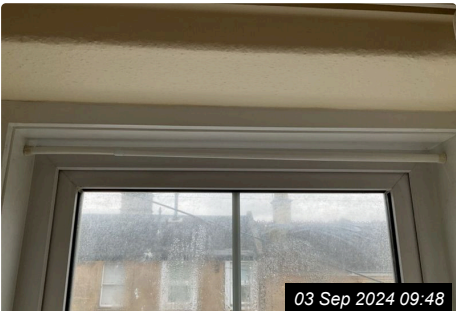
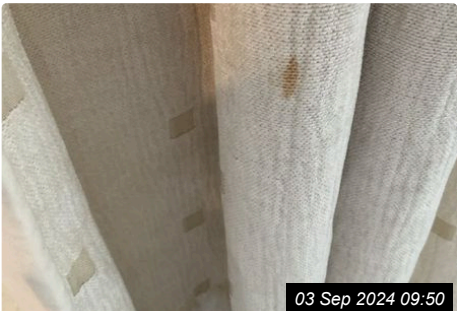
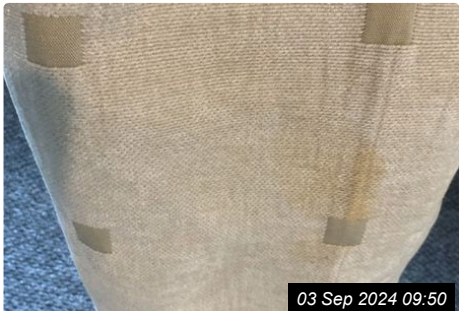
6.5

Tension rods in both windows  
Marks on curtain fronts  
String on right hand track

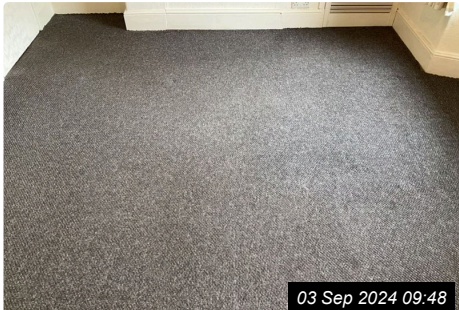
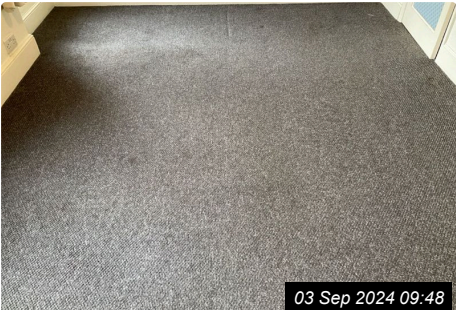
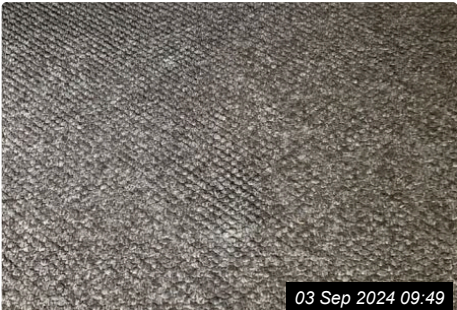
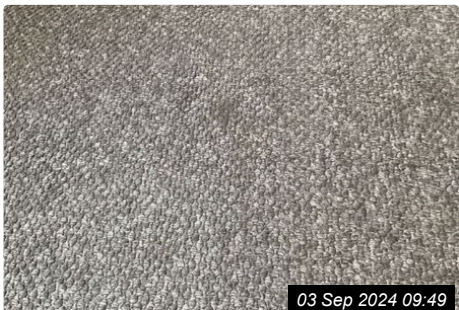
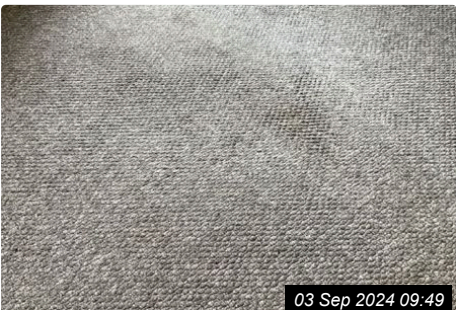
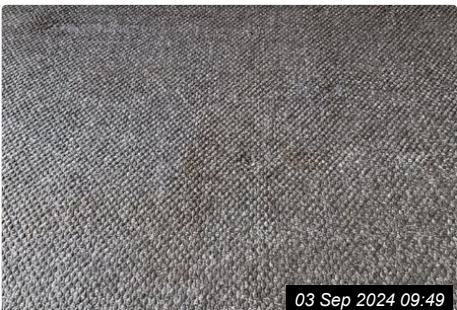
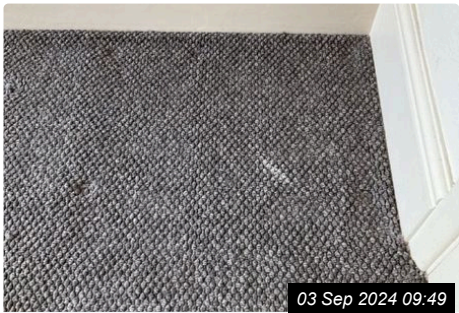
| 6.6<br>📷 | Flooring | Grey fitted carpet | White marks by the door<br>Dark marks in middle of the room<br>Dirty along far wall by kitchen<br>Furniture indents | |

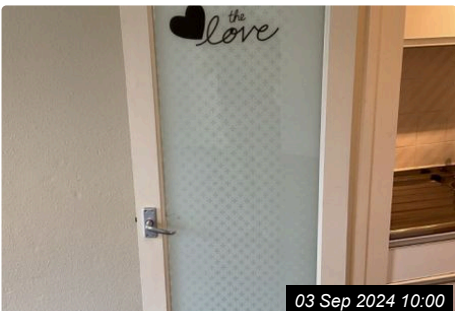
| Ref | Name | Description | Condition | Additional Comments |
|---|---|---|---|---|
| 7.2<br> | Door | Single glazed door | Film and decal on glazing | |

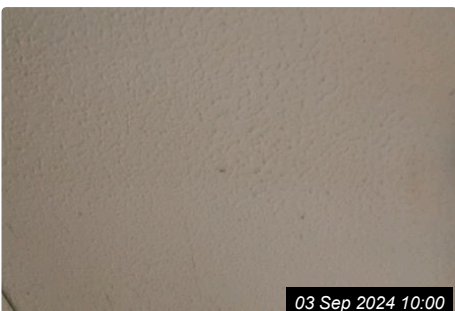
| 1. SCHEDULE OF CONDITION | | | |
|---|---|---|---|
| 1.4 | Ceiling(s) | Marks to kitchen ceiling above extractor hood | |

| 7.3<br> | Ceiling | Artex | Marks by light above the extractor hood | |

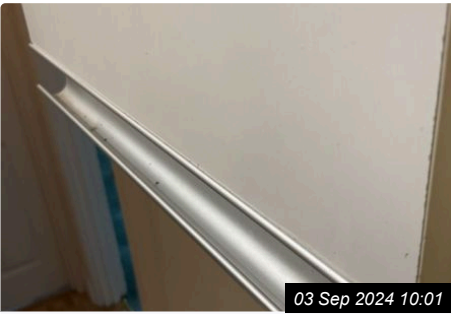
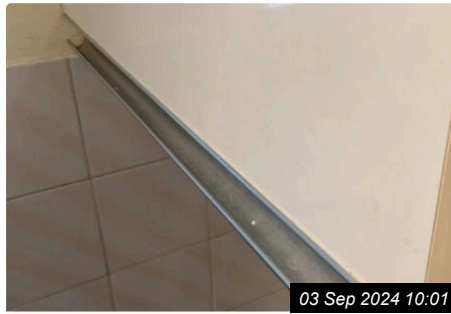
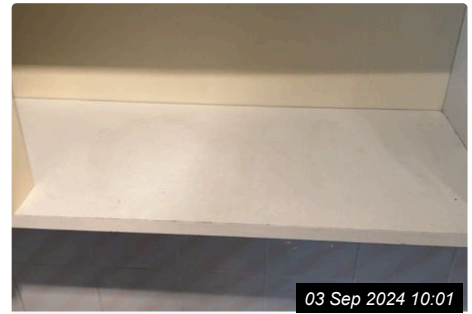
| 7.4<br> | Kitchen Units | <p>Base units</p> <p>Wall Units</p> | <p>Debris in handles of doors</p> <p>Debris/crumbs inside units</p> | |

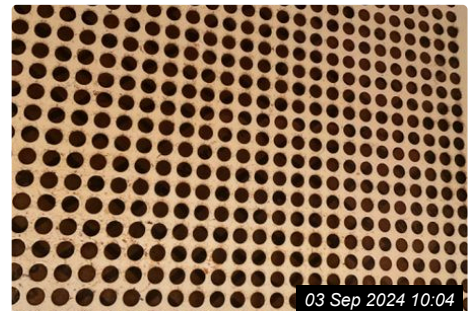
7.5  
📷

| 1. SCHEDULE OF CONDITION | | | |
|---|---|---|---|
| 1.11 | Oven / Hob / Extractor Hood / Cooker | Extractor hood smells badly of grease when activated | |

Grease and strong grease smell  
when activated

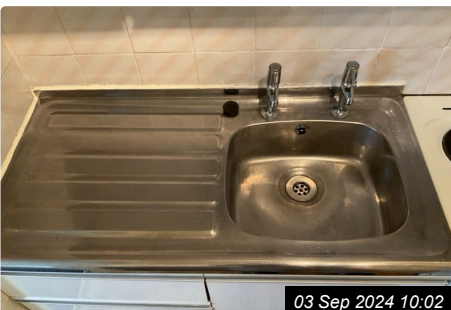
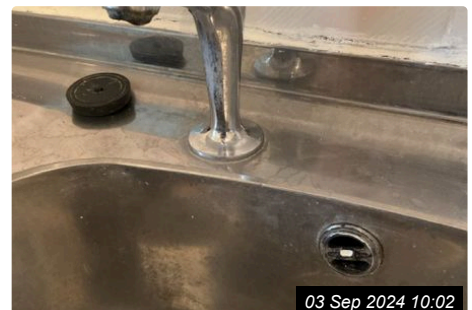
7.6  
📷

Water marked/smeared

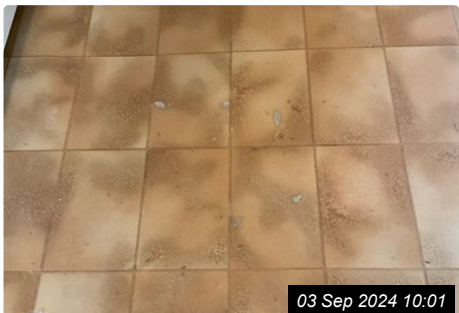
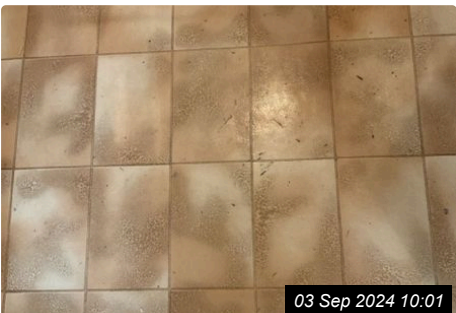
7.7  
📷

Dents and scuffs

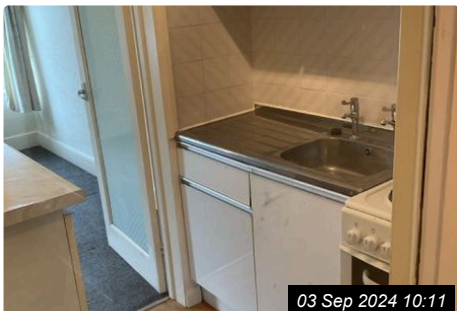
| Ref | Name | Description | Condition | Additional Comments |
|---|---|---|---|---|
| 8.2 | Door | Single glazed door | Dirty in glass pane | |

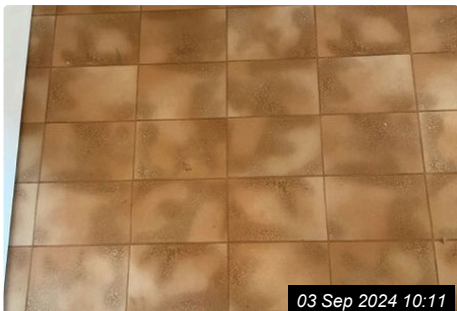
| 8.3 | Flooring | Linoleum | Dents and scuffs | |

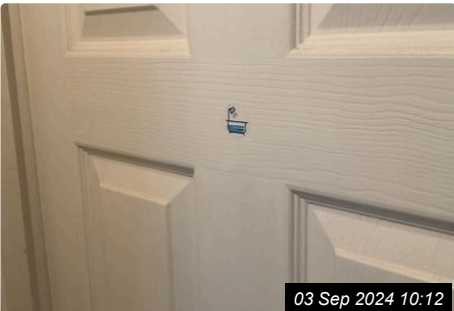
| Ref | Name | Description | Condition | Additional Comments |
|---|---|---|---|---|
| 9.2 | Door | White painted wooden door | External - sticker in middle section<br>Internal - cracking paint around the handle | |

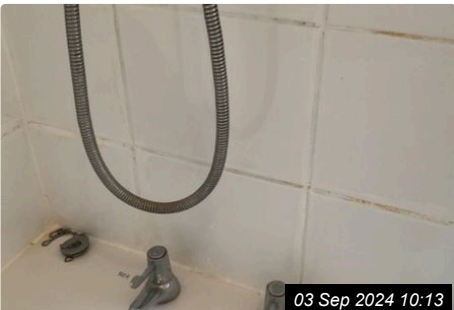
| 9.3 | Walls | Tiled and wallpapered | Grout behind the taps discoloured<br>Stains right of the basin | |

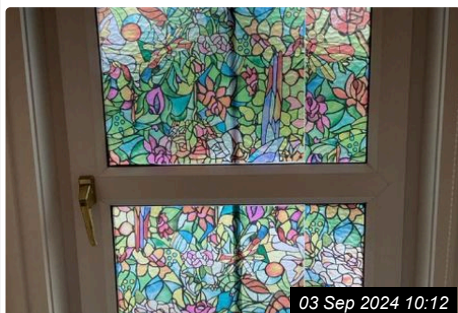
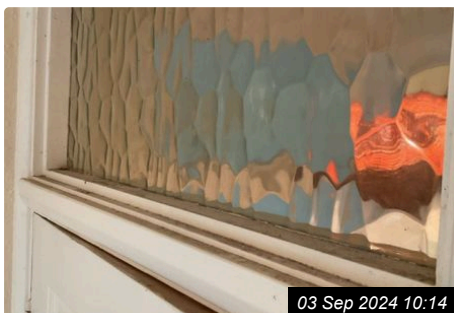
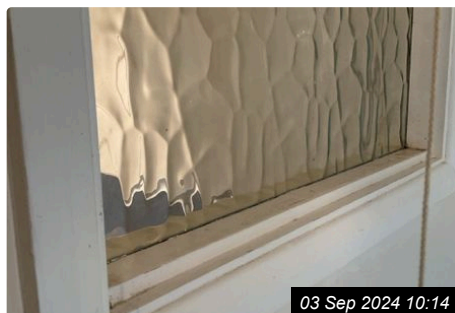
| 9.4 | Window(s) / Sill | Casement - obscure glass<br>Casement - double glazed | Dusty in frame on internal window<br>Stain glass effect film on double glazed window | |

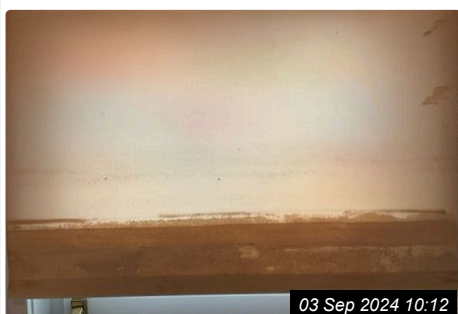
9.5  
📷

Dark/dirty mark on the bottom

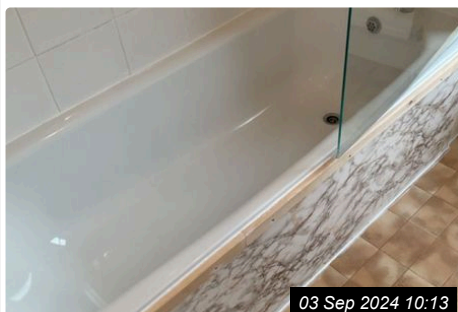
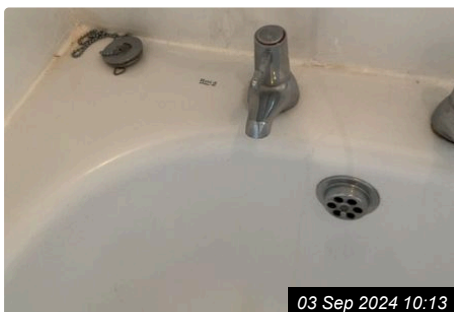
9.6  
📷

Plug and chain not attached  
Smears to the glass screen

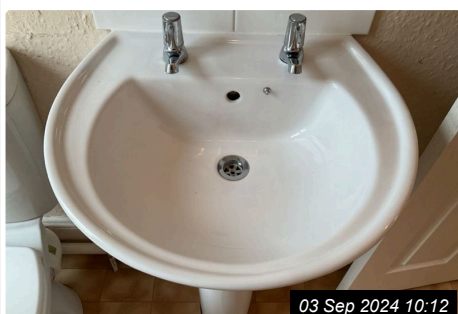
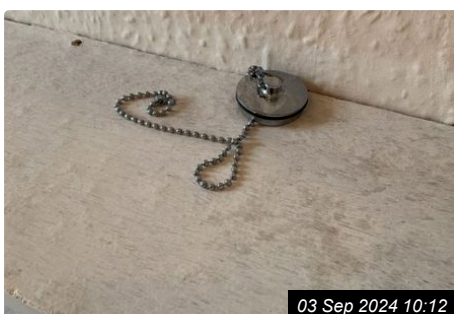
9.7  
📷

Plug/chain not attached

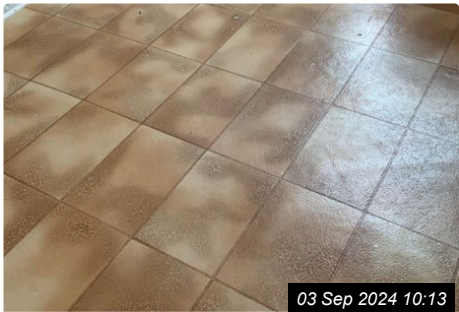
| 9.8<br>📷 | Flooring | Linoleum | Debris visible | |

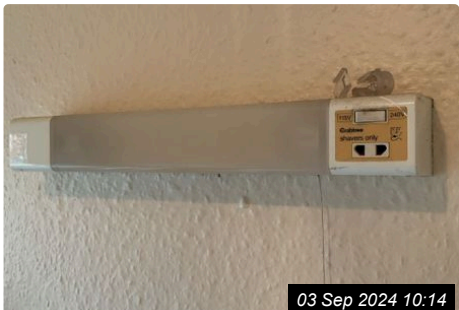
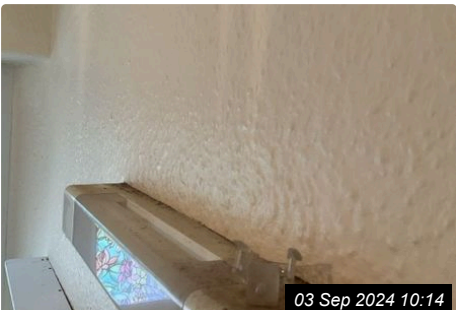
| 9.9<br>📷 | Additional Items / Information | Shaver light and socket | Light not working<br>Very dusty/dirty on top | |

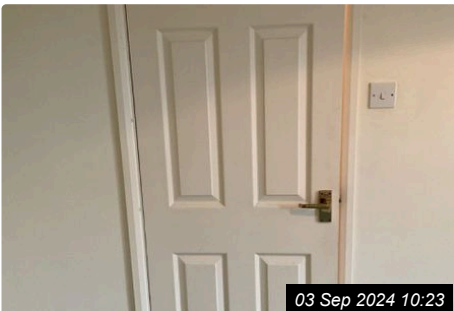
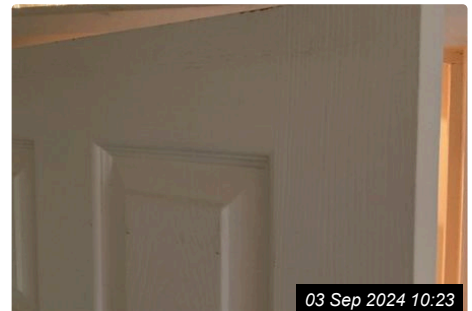
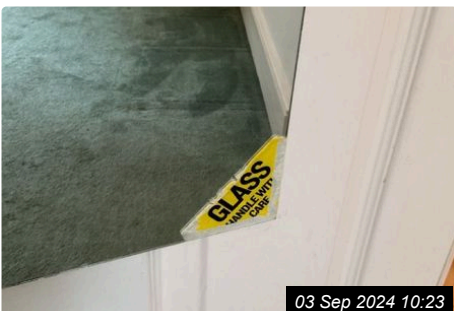
| Ref | Name | Description | Condition | Additional Comments |
|---|---|---|---|---|
| 10.2<br>📷 | Door | White painted wooden door with mirror | <p>Sticker on bottom right corner</p> <p>Internal - chipped on top edge, marks/stains top left panel</p> | |

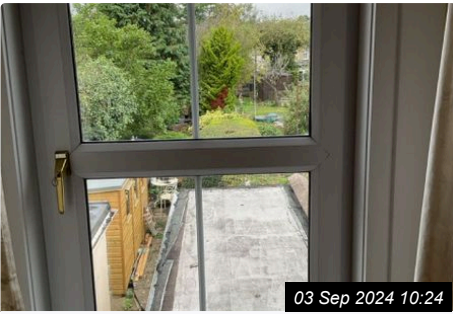
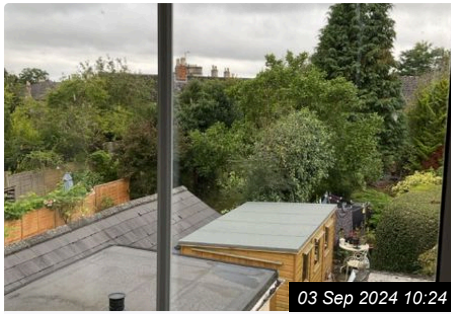
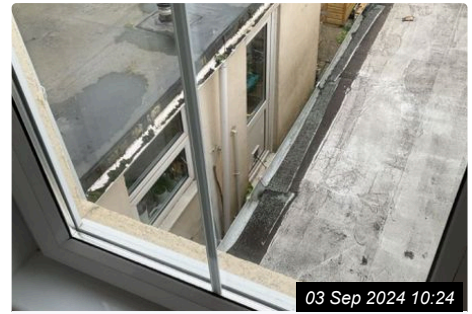
| 10.3<br>📷 | Window(s) / Sill | Casement - double glazed | Dirty panes of glass | |

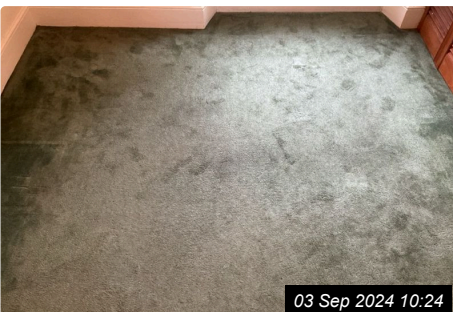
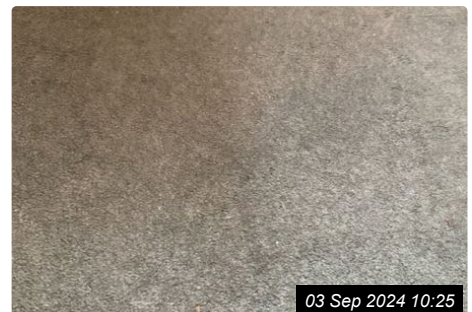
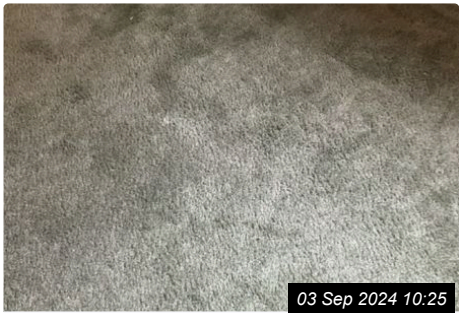
10.6  
📷

Furniture indentations  
Appears not to of been cleaned/  
vacuumed with white debris visible
