# Check Out

Property inspected by Kelvin Bateson-Keys

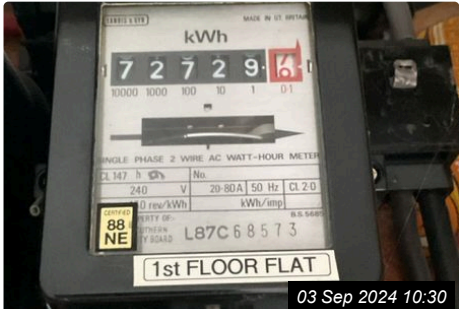
Ref # 2.2

| 2.2 | Electric Meter | Location: Hallway cabinet above front door<br><br>Serial No: L8 7C68573 | 72729 | |

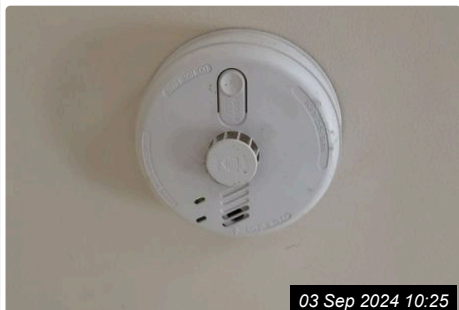
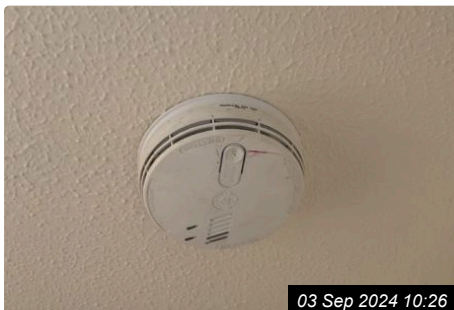
Ref # 4.1

| Ref | Name | Answer | Comments | Additional Comments |
|---|---|---|---|---|
| 4.1<br> | Smoke alarm present on each floor,<br>Smoke alarm tested / green light visible | Yes | Lounge - audible sound heard<br>Kitchen - audible sound heard | |

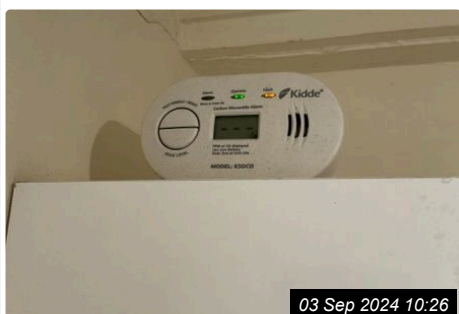
Ref # 4.3

| 4.3<br> | Carbon monoxide alarm present &<br>working in any rooms with working fires<br>(e.g. gas fire / open fire / wood burner)? | Yes | Kitchen - audible sound heard | |

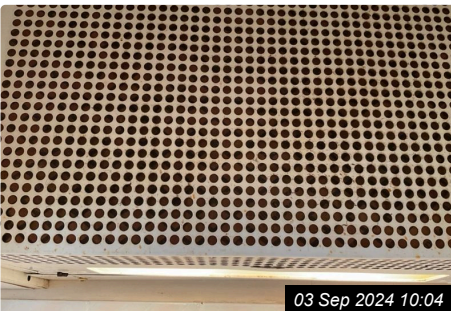
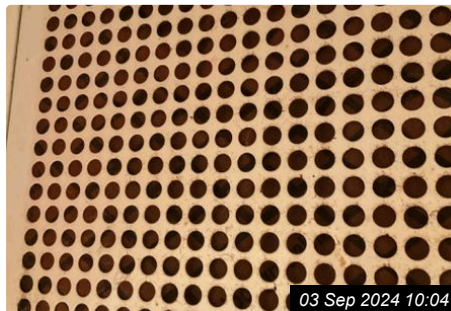
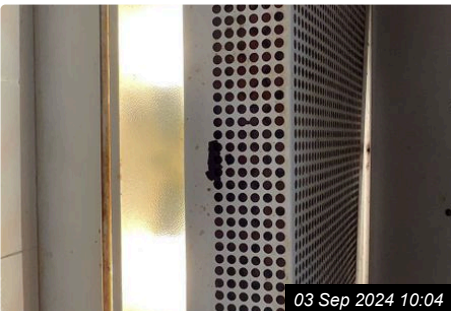
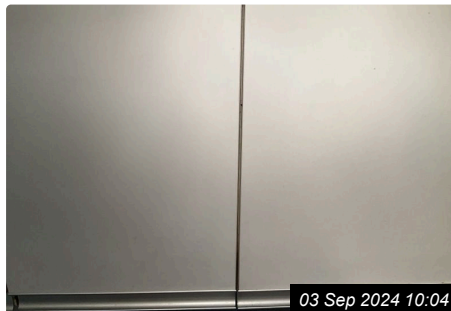
Ref # 7.5

Cooker hood

Grease and strong grease smell  
when activated

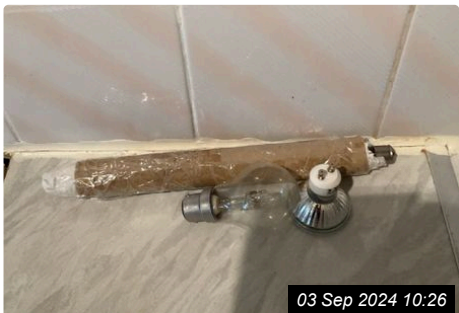
Ref # 7.8

| 7.8<br>📷 | Additional Items /<br>Information | 3 light bulbs | Left on the worktop right of the hob | |

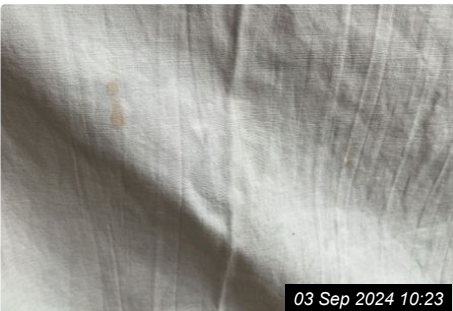
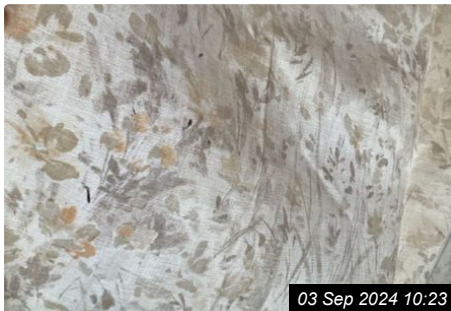
Ref # 10.4

Curtain rail  
Curtains

Dust and marks on lining of both  
curtain's

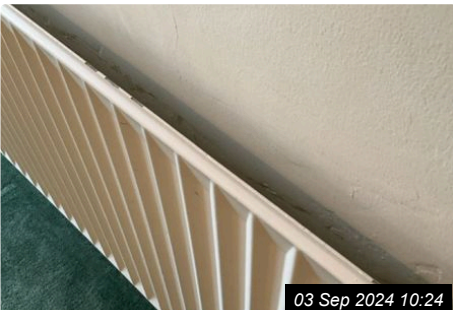
Ref # 10.5

White wall mounted radiator

Chipped along top edge
